Septic Systems and Nutrients

STATE OF MICHIGAN, DEPARTMENT OF ENVIRONMENTAL QUALITY

Nutrient Framework to Reduce Phosphorus and Nitrogen Pollution

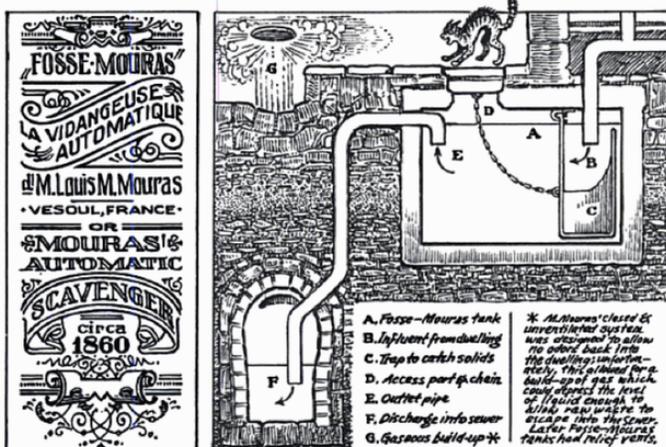
Fig 1. Schematic of an early-design septic tank from 1860. (from <http://djwl.co.uk/blog/brief-history-septic-tanks/>)

The invention of the first septic tank is often credited to a Frenchman by the name of Jean-Louis Mouras in 1860 (Fig. 1). Mouras invented a tank for waste disposal with the idea that storing the solid wastes would be a better disposal method than discharging them straight into the nearest waterway. Which, up until then, had been the preferred method of waste disposal. The first septic tank was later installed in the U.S. in 1883. Some 50-60 years later, drainfields or “soakaways” were recognized as being necessary for the liquid effluent that left the tank. Today, the basic design and concept of the septic tank system has changed little from its earlier prototypes.

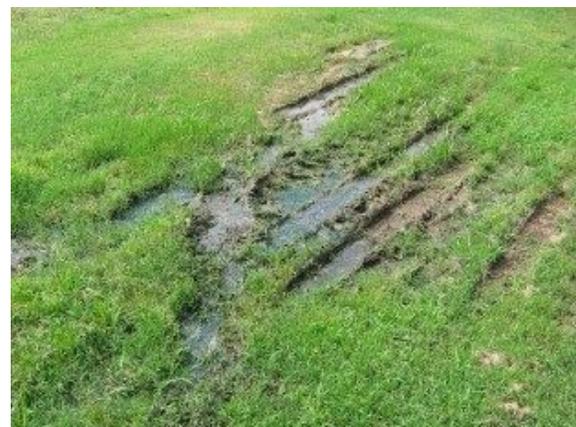
Figure 2. Saturated drainfield that has become clogged and has ponding water at the lawn surface. Photo from <http://www.aero-stream.com/septic-tank-problems.html>

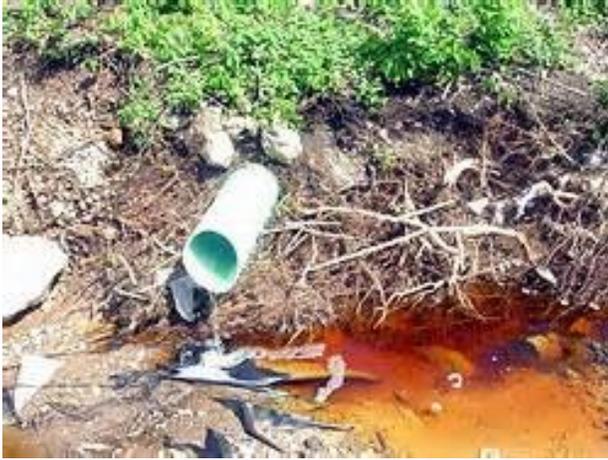
Fig 3. Illicit sewage discharge to a ditch. Photo from www.oregonohio.org.
